ST MARTIN GOSPEL OAK

QUINQUENNIAL INSPECTION • DEC 2016 • REES BOLTER ARCHITECTS

**ST MARTIN, GOSPEL OAK
QUINQUENNIAL INSPECTION 2016**

Date of inspection: 19 December 2016

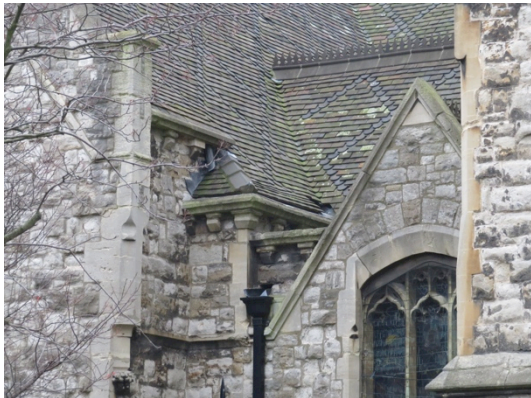
Complicated area of rainwater disposal adjoining the north transept.

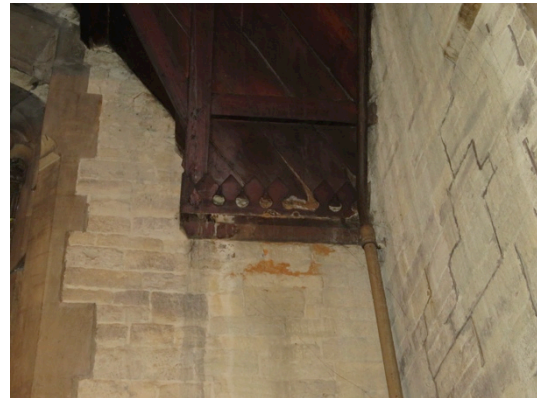
Signs of possible damp penetration below this complicated area.

- 12.1 The main church roof is an open structure of immense complexity. It is difficult to obtain a clear view of the roof because of glare from windows and light fittings but no significant problems were seen. Damp staining is believed to be from leaks prior to the re-roofing of 2004. Tie rods may be an early addition
- 12.2 The hall has a plaster barrel vault of plaster. No defects were noted other than cracking associated with the structural movements within the supporting walls. These should now be repaired.
- 12.3 The ceiling above the bells is supported on steel joists. These have surface rust and would benefit from painting.
- 12.4 There are some signs of dampness at high level to the right of the window behind the north altar. This area should be checked with a damp meter and the

rainwater disposal arrangements in the vicinity should then be checked if moisture levels are high.

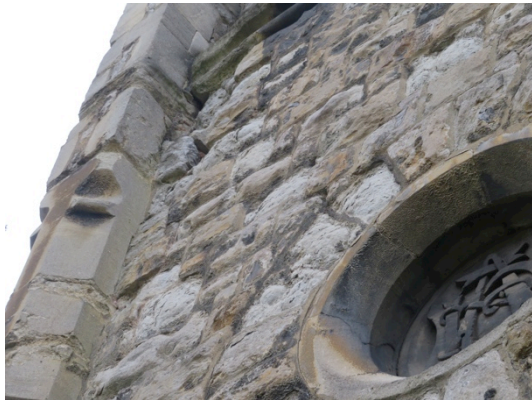
Weathering back of ragstone at the west end of the south elevation. Much past repair in cement.

- 7.3 There are areas of ragstone which have weathered back significantly, and where unsympathetic past refacings in cement may be seen. This is most pronounced on the west end of the south elevation of the nave, where some stone is now missing, and the four large pinnacles which flank the nave and chancel.

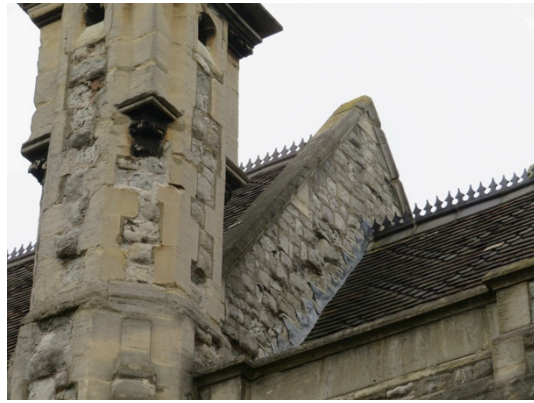
A further area of concern above the abutment of the chancel roof with that of the nave.

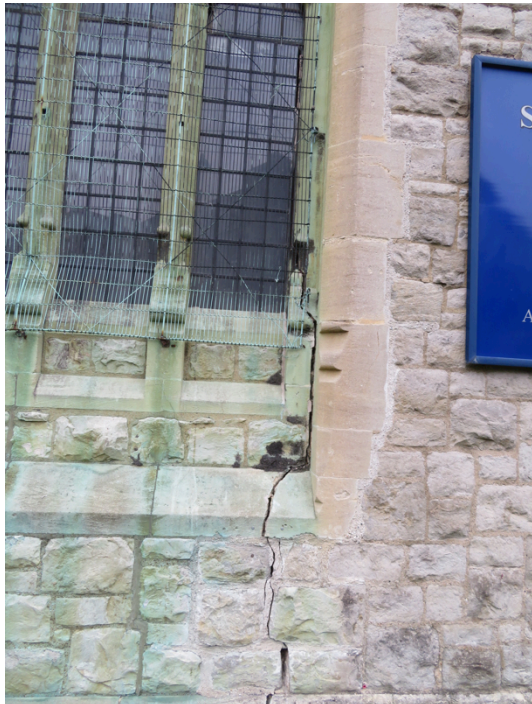
Cracking and damage the west window of the former choir vestry now requires repair.

- 9.5 The four windows to the hall were damaged during as a consequence of structural movements in the hall and require repair :

The north and south window need to have the guards removed and then be carefully inspected and any cracked joints packed and filled. The west window requires more extensive work. The window has, effectively become wider, leaving gaps between the stone and the glazing. The right hand intermediate transom needs to be taken out and replaced and the bottom right hand stone needs to be taken out and reset. Stone in other areas requires packing and or dressing,

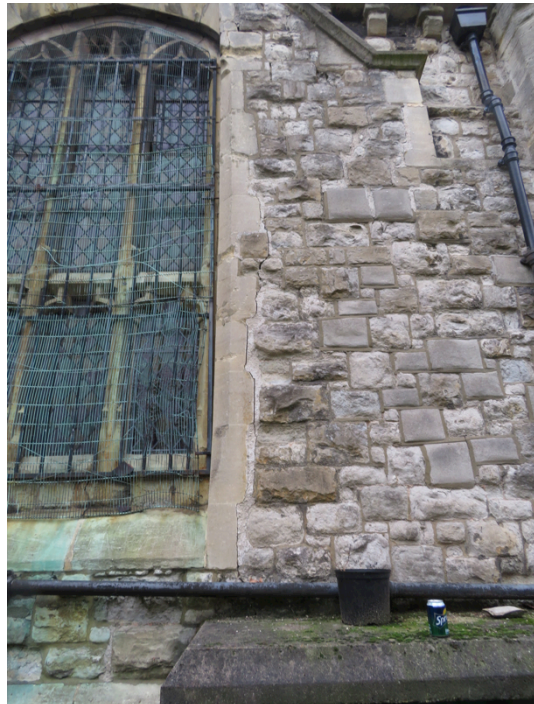
Cracking has recurred beside the garden room window.

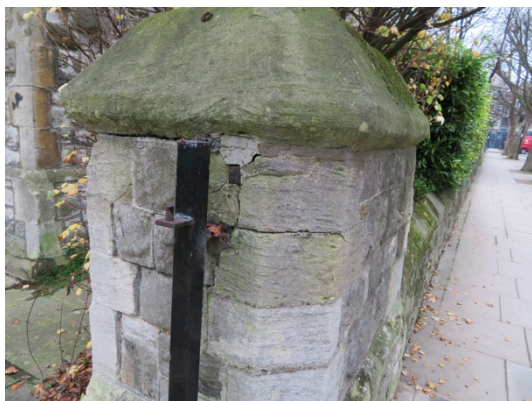
Cracking in the north east gate pier.

35.4 The walls along the north side of the churchyards are poor in places, particularly towards the east end, where the wall bulges and some stones are missing. The cap stones to the eastern gate are lifting because of expansions of rusting embedded ironwork. Repairs are needed to prevent further decay. Vegetation to this wall should be kept under control.

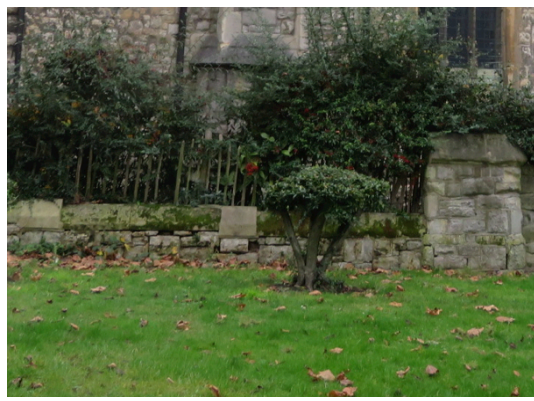
Repairs required to the south boundary wall.

35.2 The wall along the south side of the churchyard is cracking, copings are lifting in places and some stones are missing. Repairs are needed to prevent further decay. Vegetation to this wall should be kept under control.
